Site Inspection Report

Orderville, Muddy Creek Gemstone Leases:
ML 19890, ML 26996, ML 27618, ML 41354 & ML 41355

Date of Inspection: June 13 & 14, 2000
Persons Present: William M. Stokes
Tom Munson, DOGM
Loy Crapo
Mike Crauso
Conditions: Hot, Dry & Clear
Lands Inspected: E $\frac{1}{2}$ NW $\frac{1}{4}$, Section 36, T. 40 S., R. 8 W., ML 19890
NE $\frac{1}{4}$ NE $\frac{1}{4}$, Section 36, T. 40 S., R. 8 W., ML 26996
NW $\frac{1}{4}$ NW $\frac{1}{4}$, Section 36, T. 40 S., R. 8 W., ML 27618
SW $\frac{1}{4}$ NW $\frac{1}{4}$, Section 2, T. 41 S., R. 8 W., ML 41354
W $\frac{1}{2}$ (including lots 1-9, 14-16) Section 31, T 40 S., R. 7 W., ML 41355

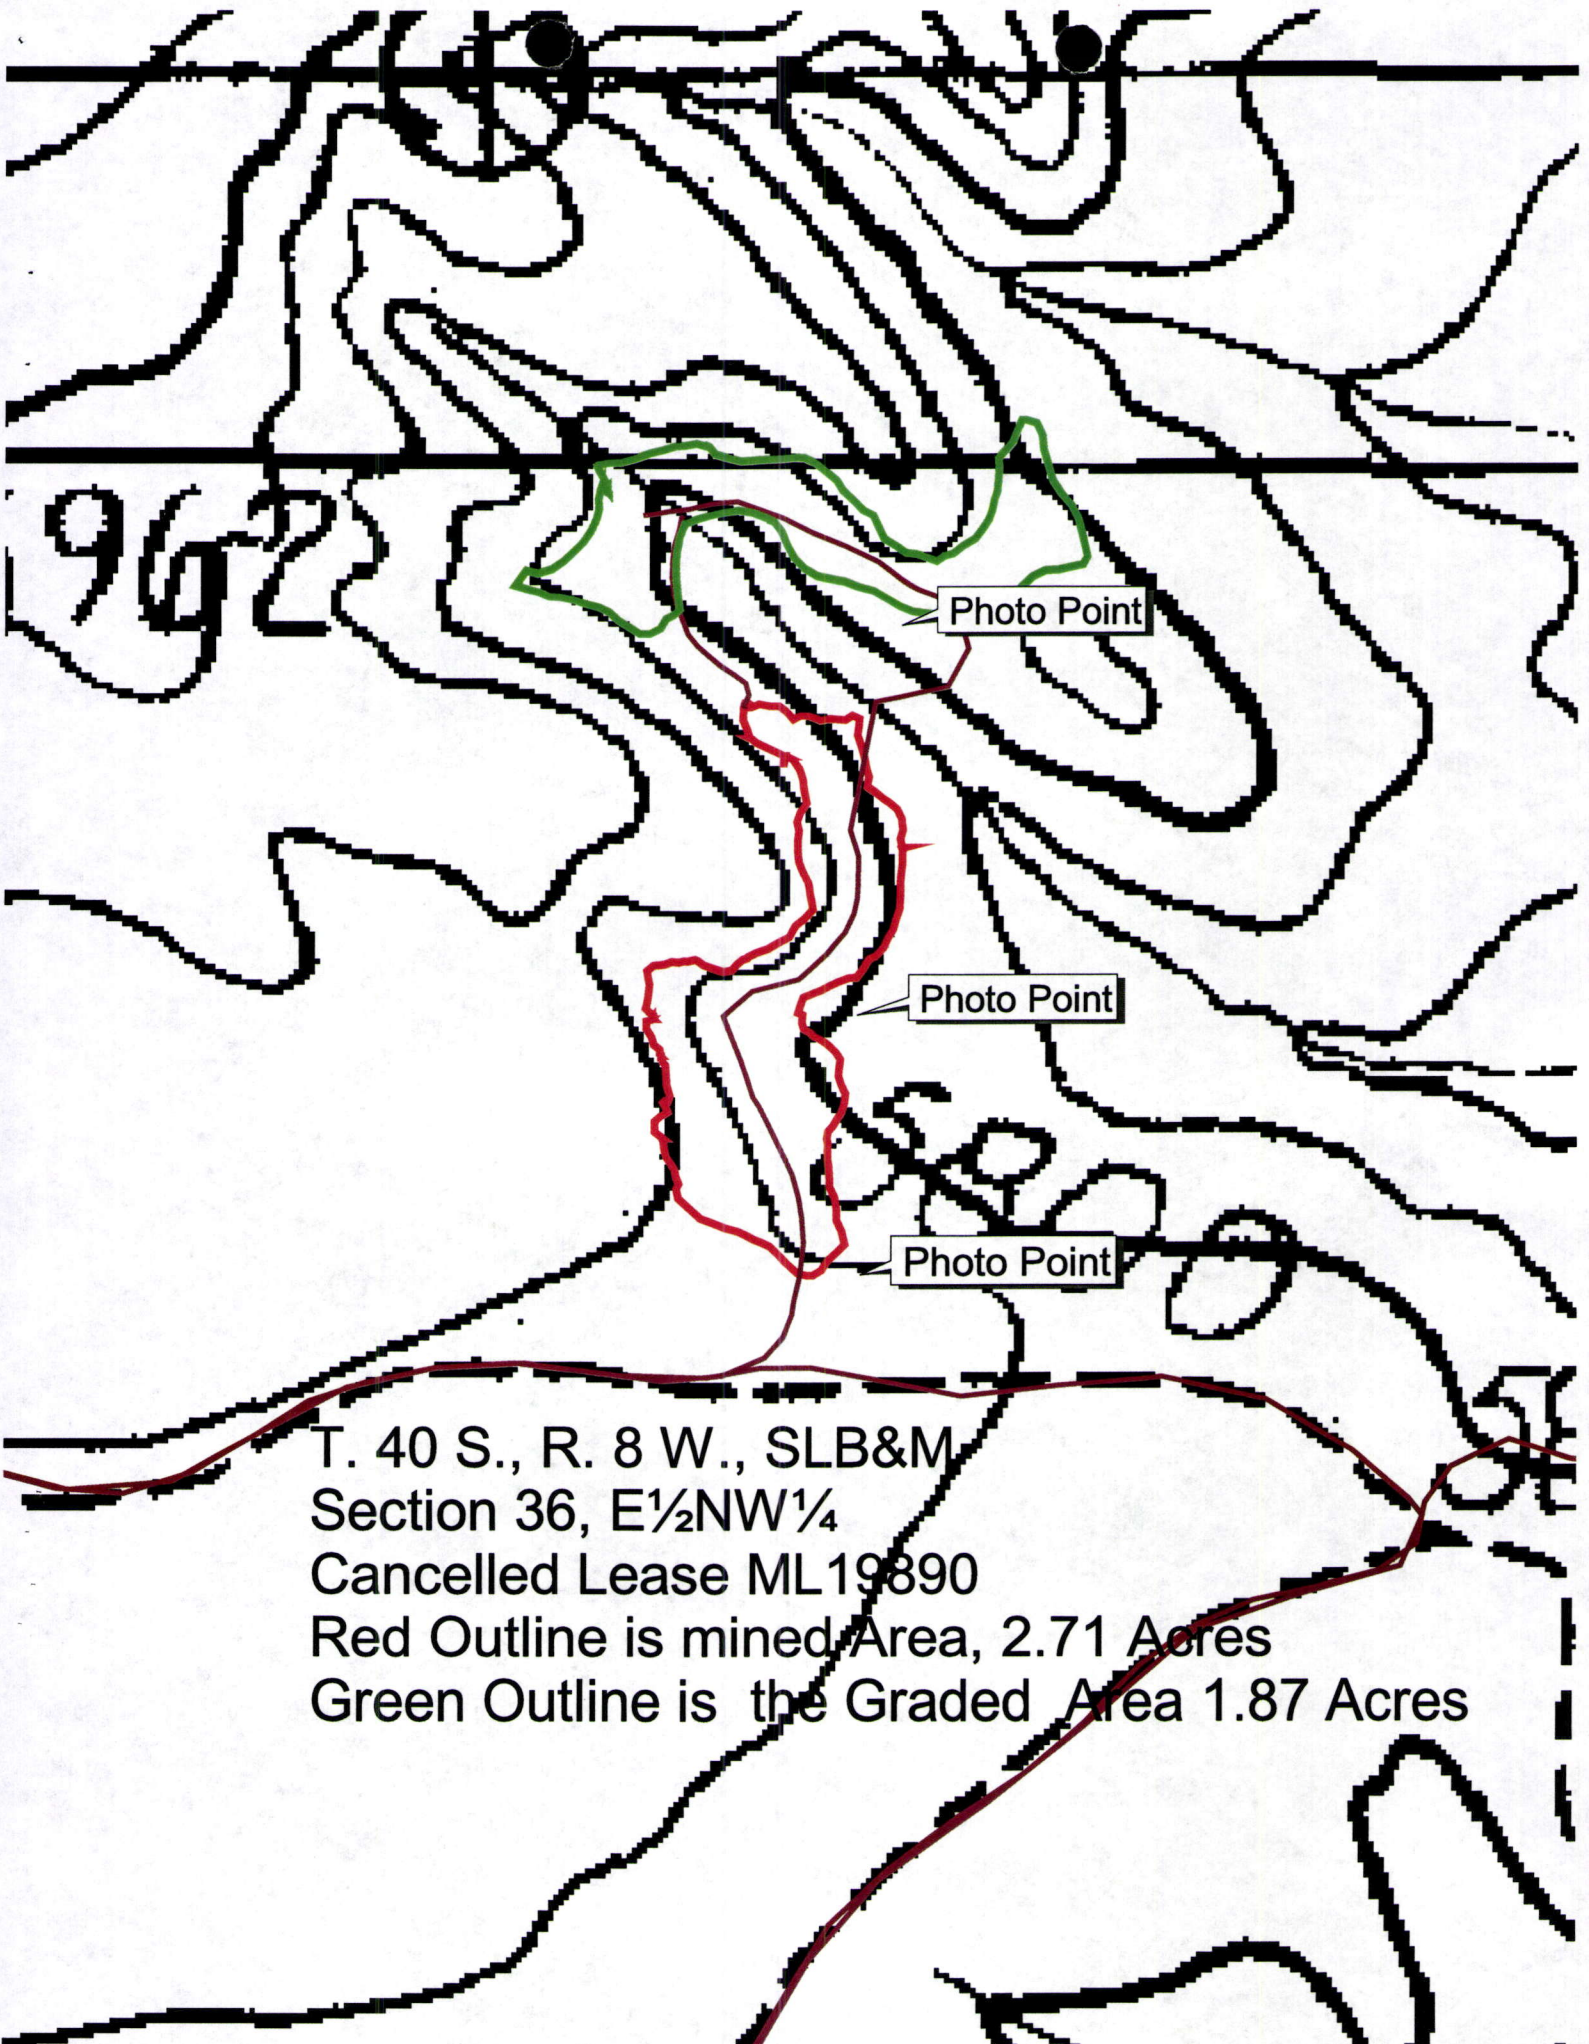
T. 40 S., R. 8 W., SLB&M
Section 36, E $\frac{1}{2}$ NW $\frac{1}{4}$
Cancelled Lease ML19890
Red Outline is mined Area, 2.71 Acres
Green Outline is the Graded Area 1.87 Acres

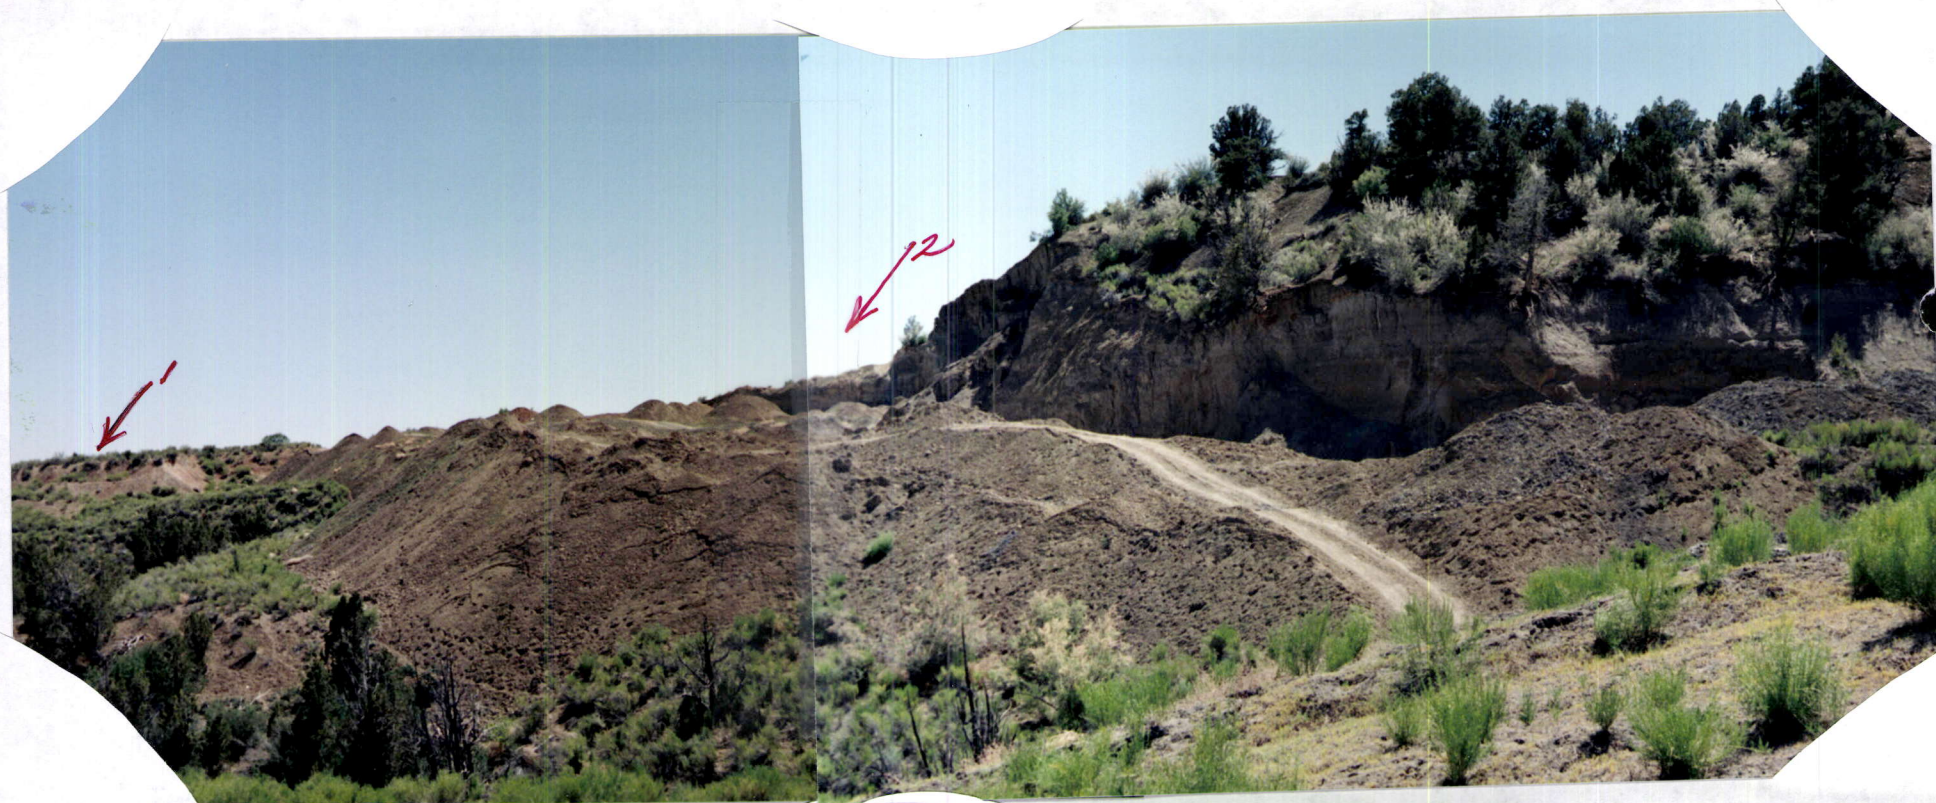
Photograph 1, Looking south from the north end of the mined area that is outlined in red on the accompanying GPS map. Arrow # 1 indicates the position from where photo. 3 was taken. The main mined are is shown in photo 3 is indicated by arrow # 2.

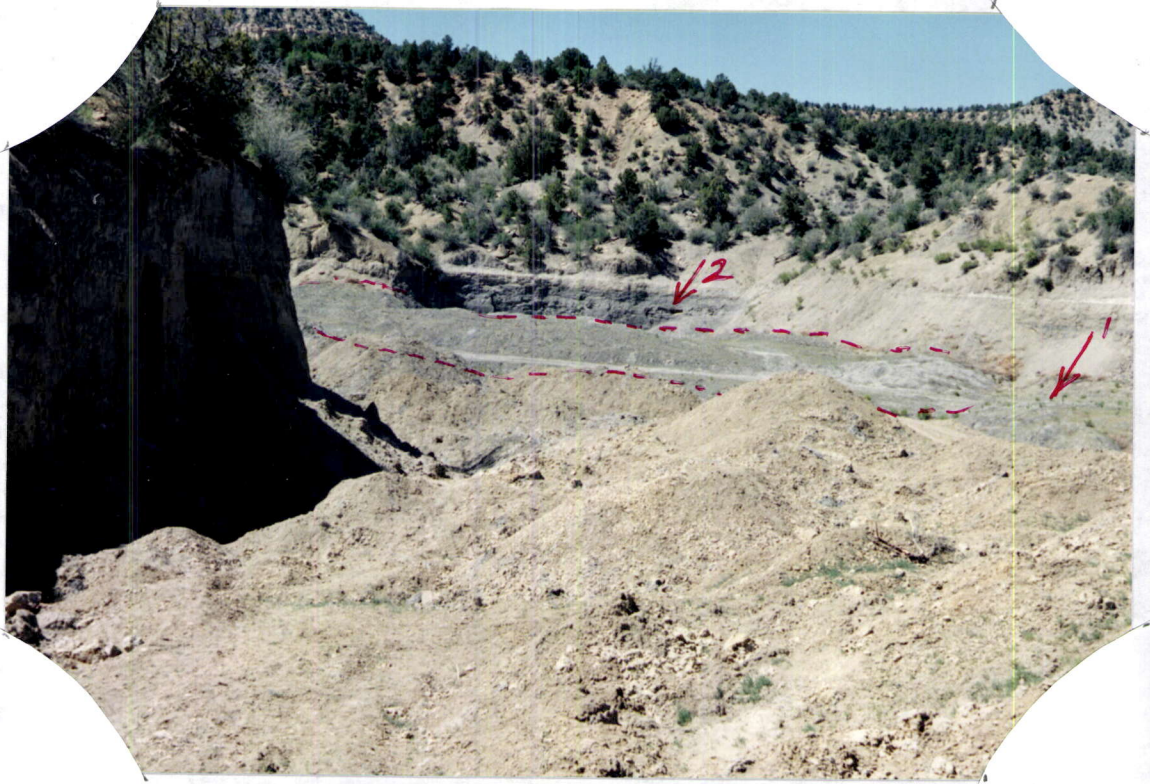
Photograph 2, Looking north from the center of the large mined area on ML 19890. The position of this photograph is indicated by arrow # 1 in photograph 3. Arrow # 1 in this photograph shows the location from where photograph # 1 was taken. Arrow # 2 indicated the mined cliff face that is on BLM land just north of the north side line of Section 36. The mined area as indicated by arrow # 2 was mined by Rex Harris on his unpatented mining claims. The dashed line shows part of the graded area that is shown on the GPS map.

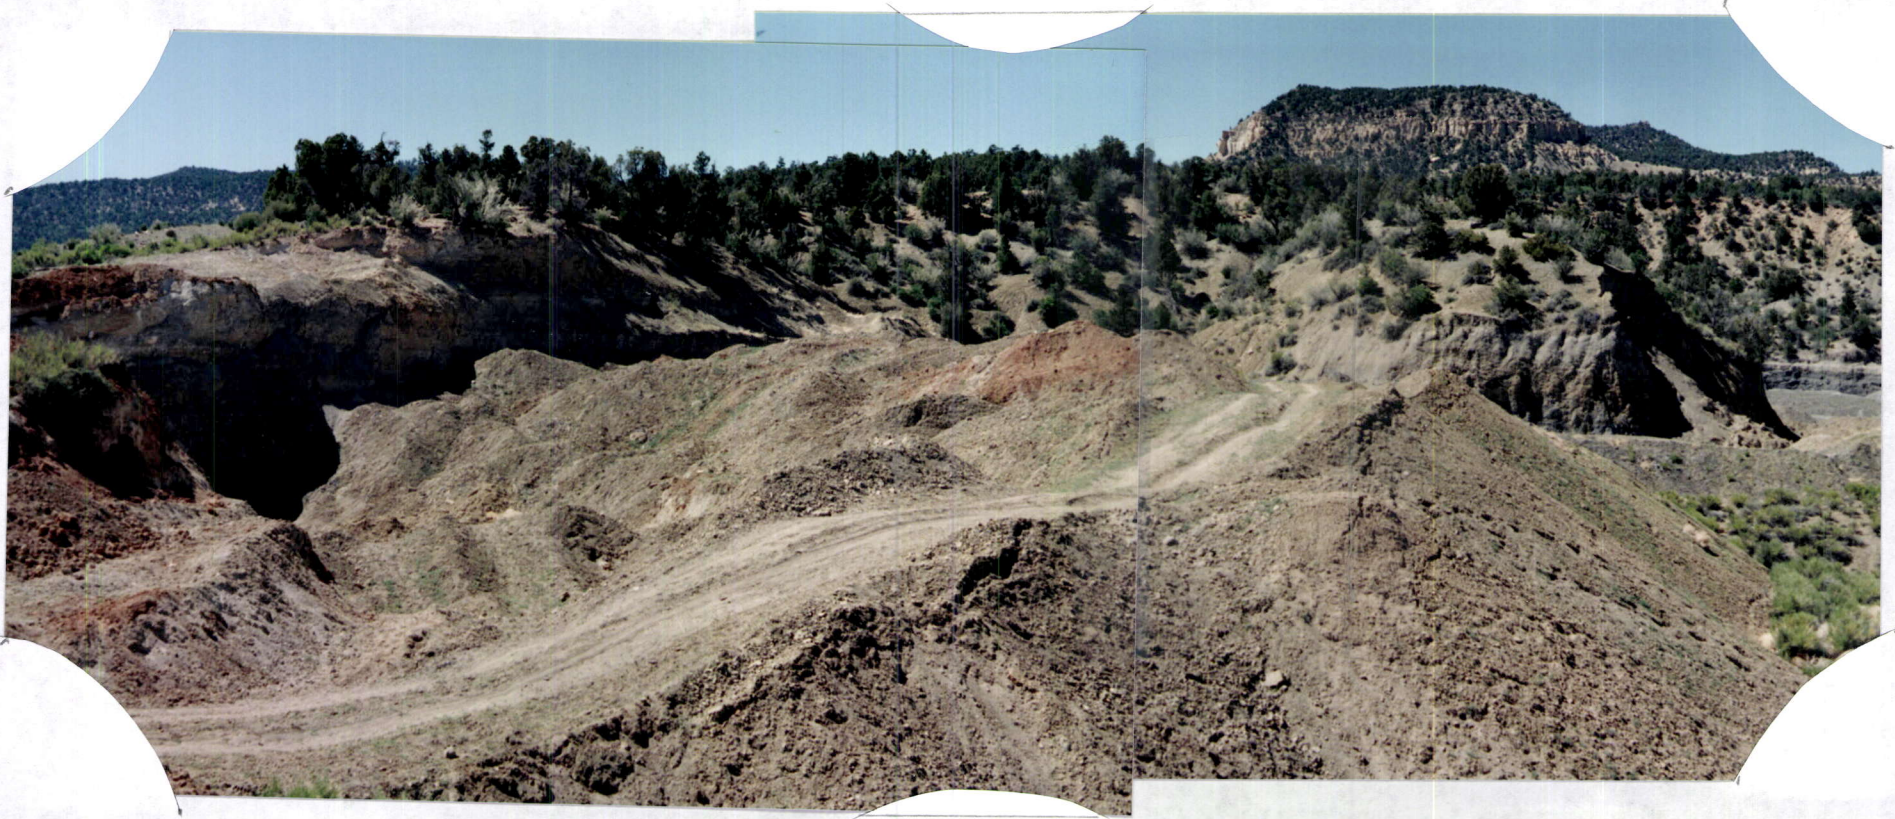
Photograph 3, Looking south from the north end of the mined area on ML 19890. The position of this photograph is shown as arrow # 1 in photograph 1. This photograph shows the conditions of the large mined area on ML 19890. Arrow # 1 shows the position from where photograph 2 was taken. Arrow # 2 shows the mined cliff face on the Harris mining claims as discussed in the caption for photograph 2.

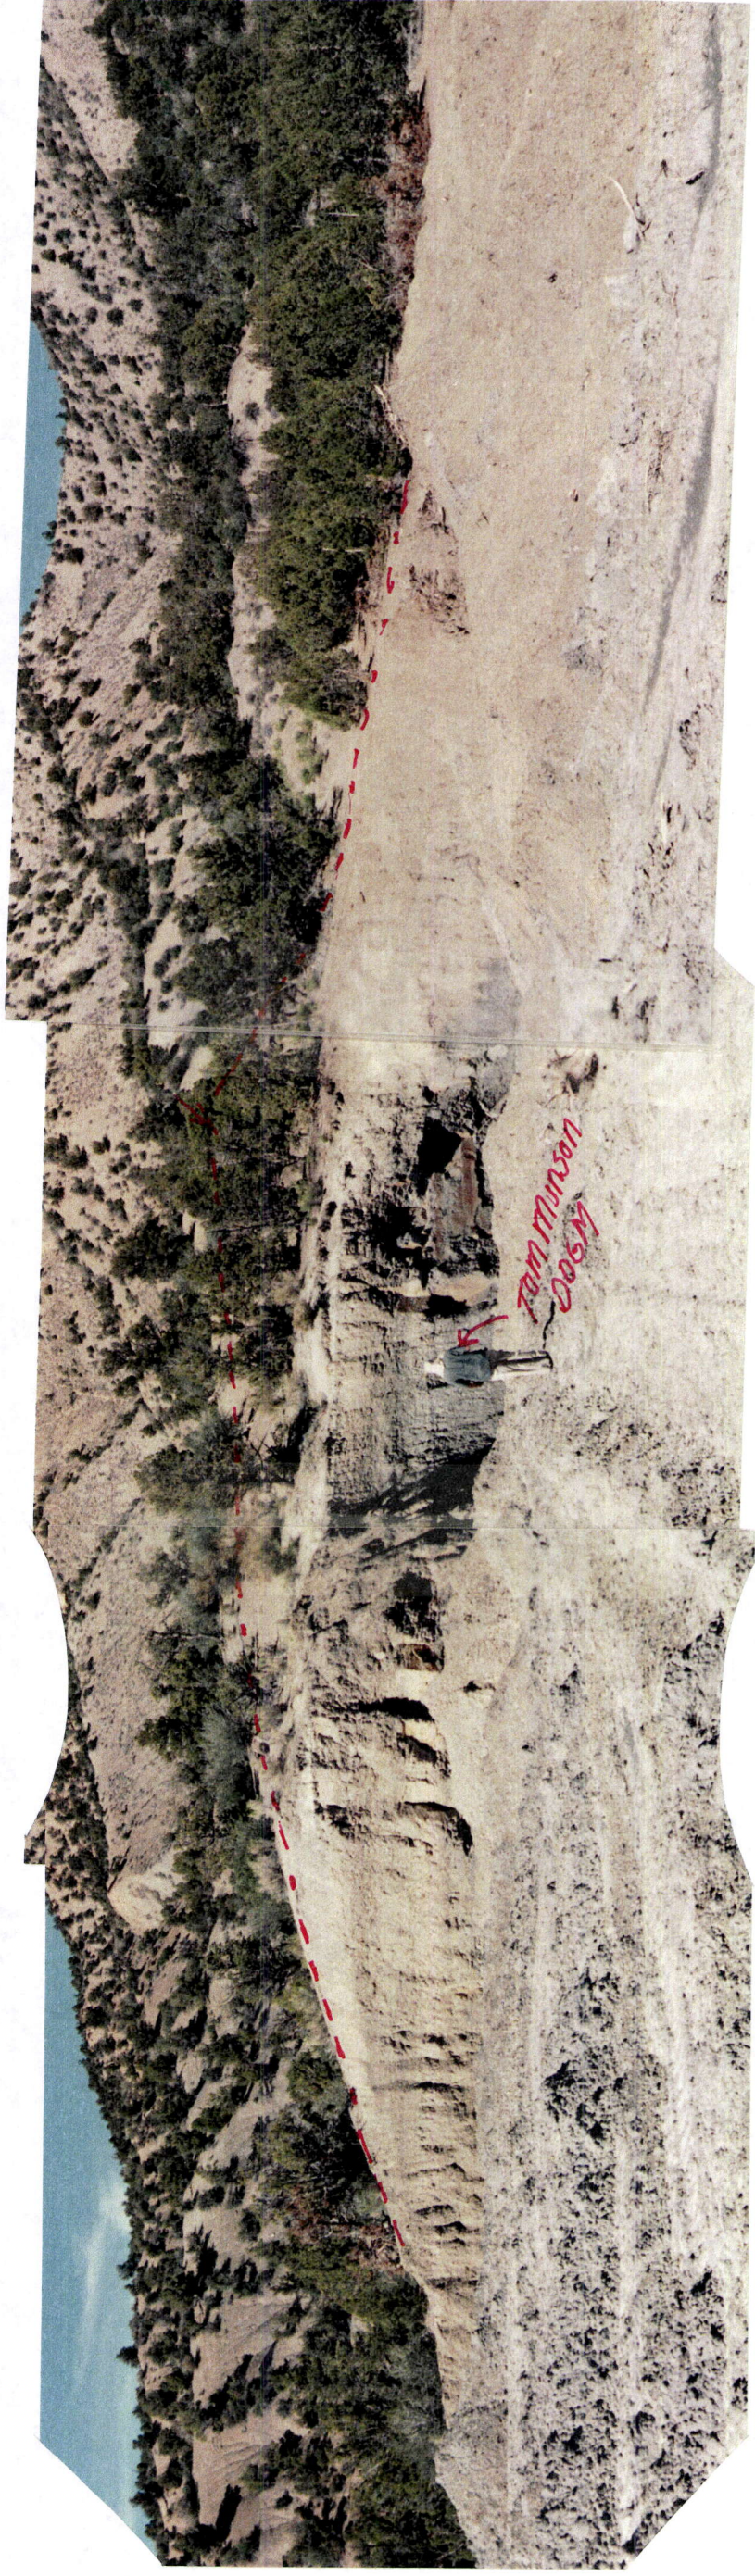
Photograph 4, Looking northeast onto the northern most mined area on lease ML 26996. The arrow shown the approximate location of the northeast corner of Section 36. The dashed line on the right shows the approximate east side boundary line of Section 36 and the dashed line on the left shows the approximate north boundary line of Section 36. The steep cliff marks the remaining unmined area between the cliff face and the Section lines which will be mined and reclaimed in the summer of 2000. In the foreground is the overburden that has been spread out away from the mined area.

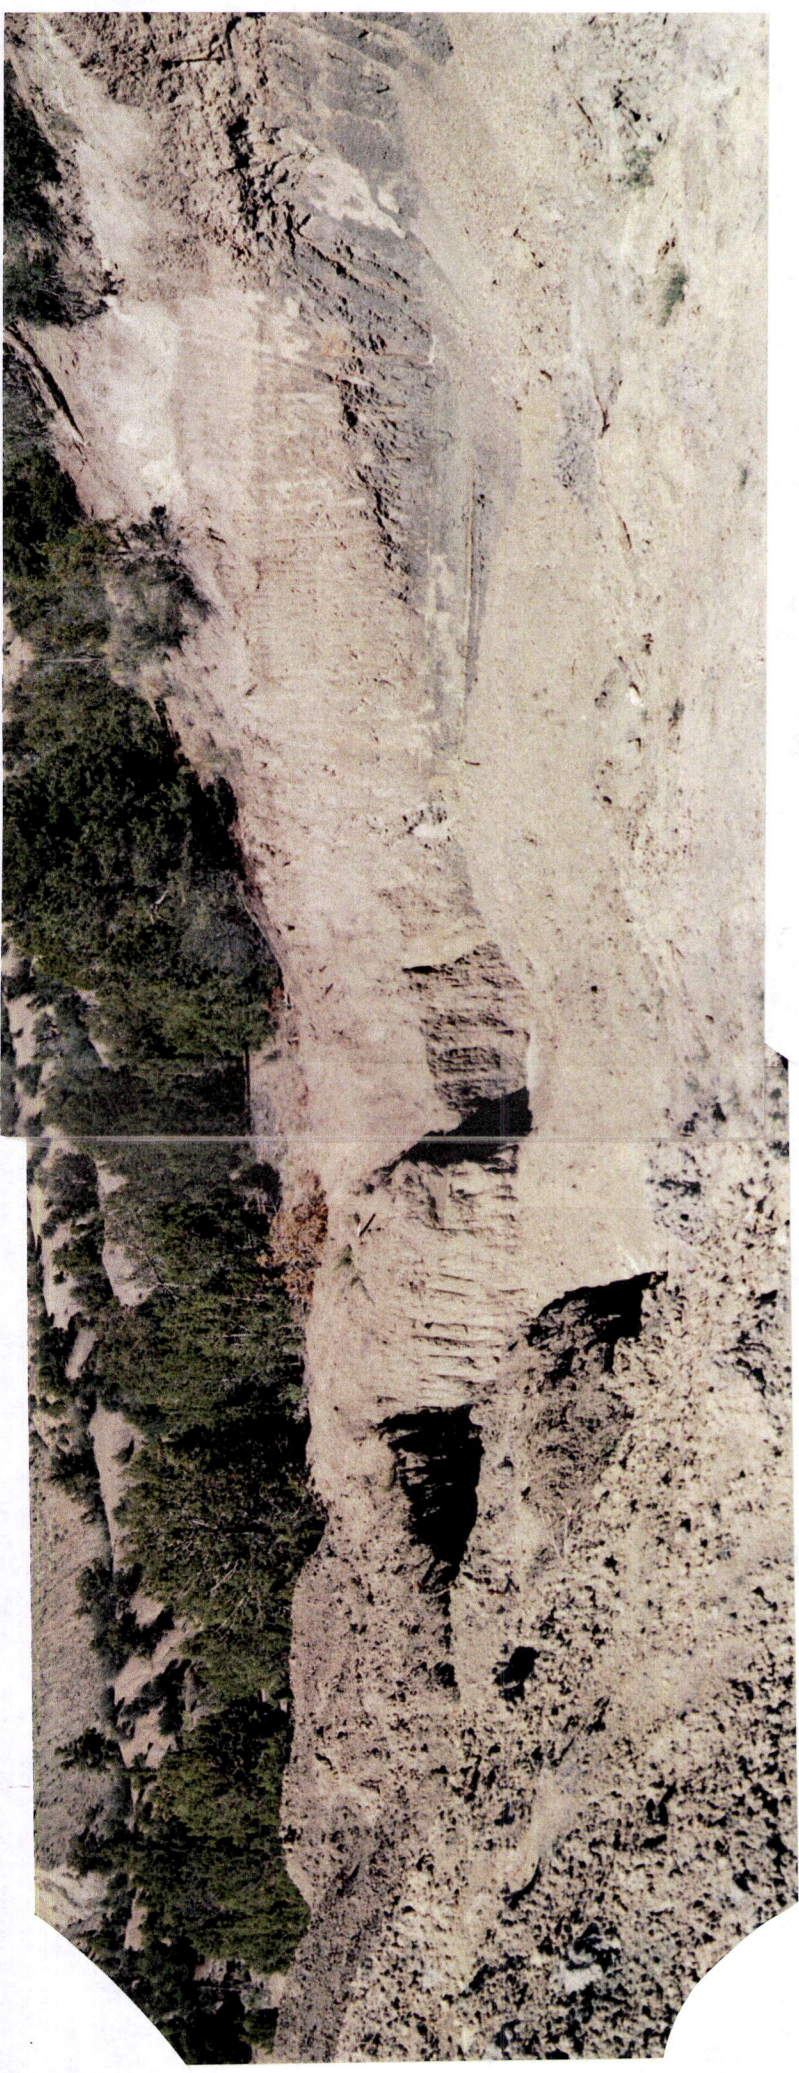
Photograph 5, Looking east onto the northern arm of the southern disturbance on ML 26996. This area was mined by Loy Crapo. The east boundary line of Section 36 runs along the edge of the mine pit.

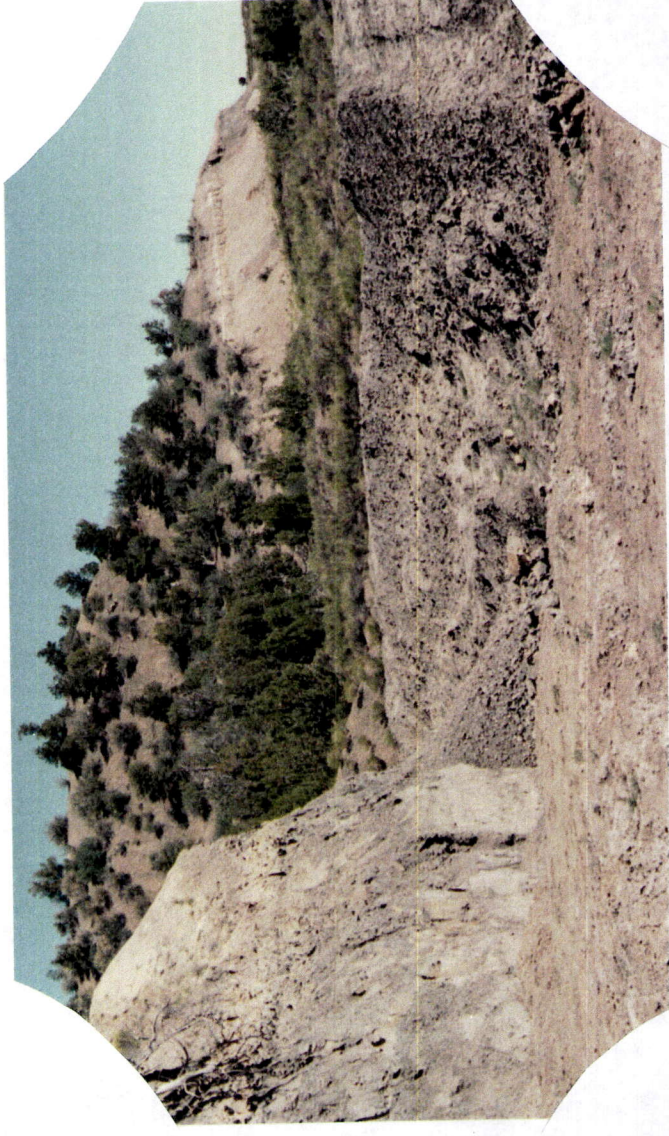
Photograph 6, Looking south from the same location as in photo 2 onto the southern arm of the southern mined area on ML 26996. The cliff on the left is the area that will be mined in the summer of 2000.

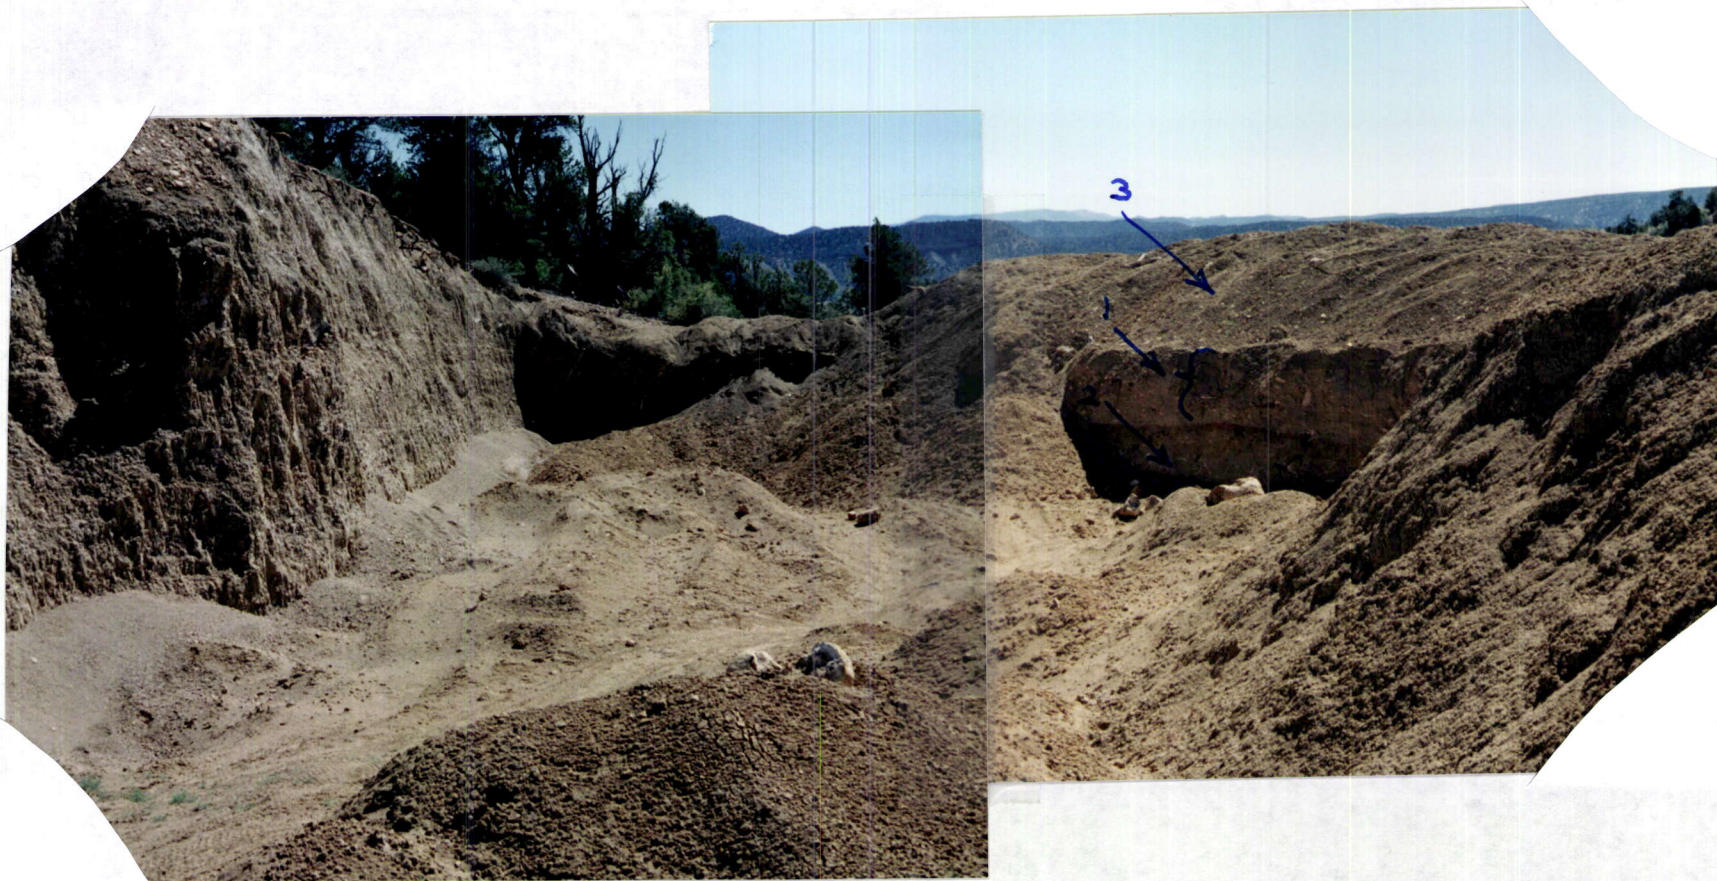
Photograph 9, Looking east from the photo point as shown on the GPS map onto the east arm of the mine area. The pit area is approximately 40 feet wide. Arrow 1 shows the layer of overburden excavated from previous mining which is sitting on top of undisturbed ground, arrow 2. Arrow 3 shows the overburden pile that was put in place by Mike Caruso in 1999.

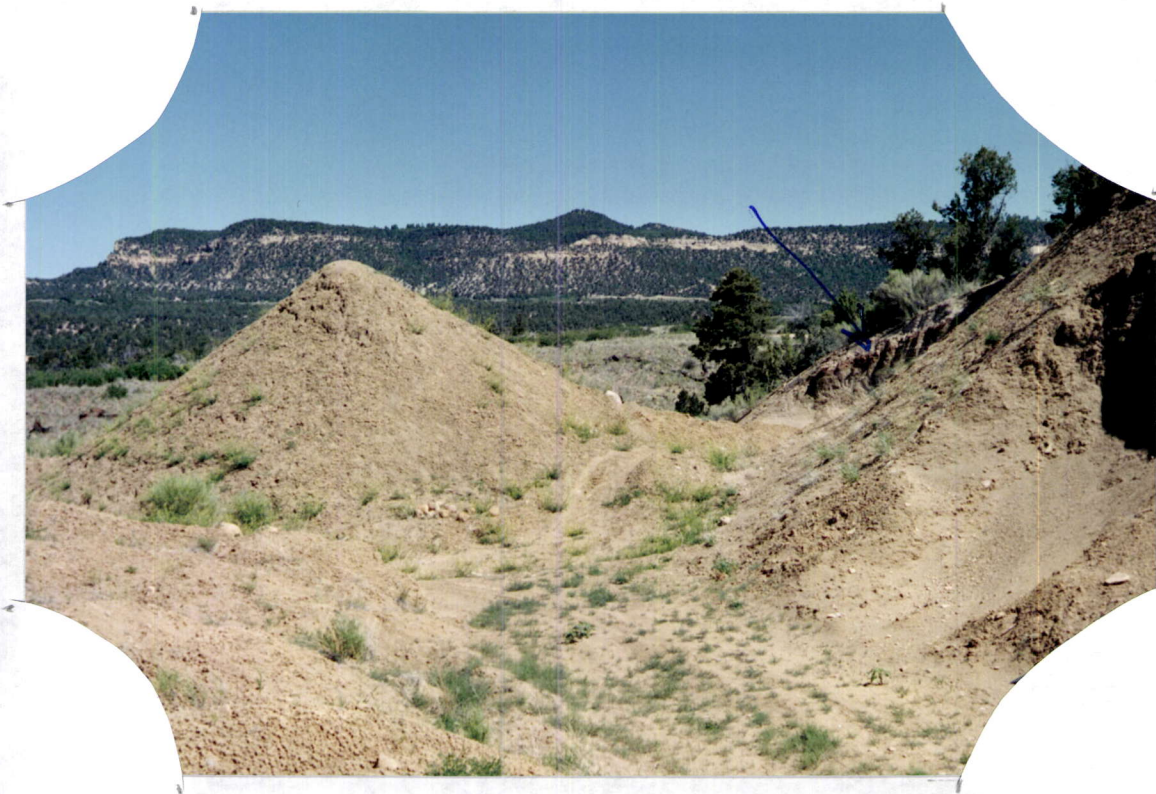
Photograph 10, Looking north from near the same photo point as in photograph 9 onto the northern arm of the mine area on ML 41354. The arrow in this photo shows the location of a recently (1999) excavated pit that is not visible from this location.

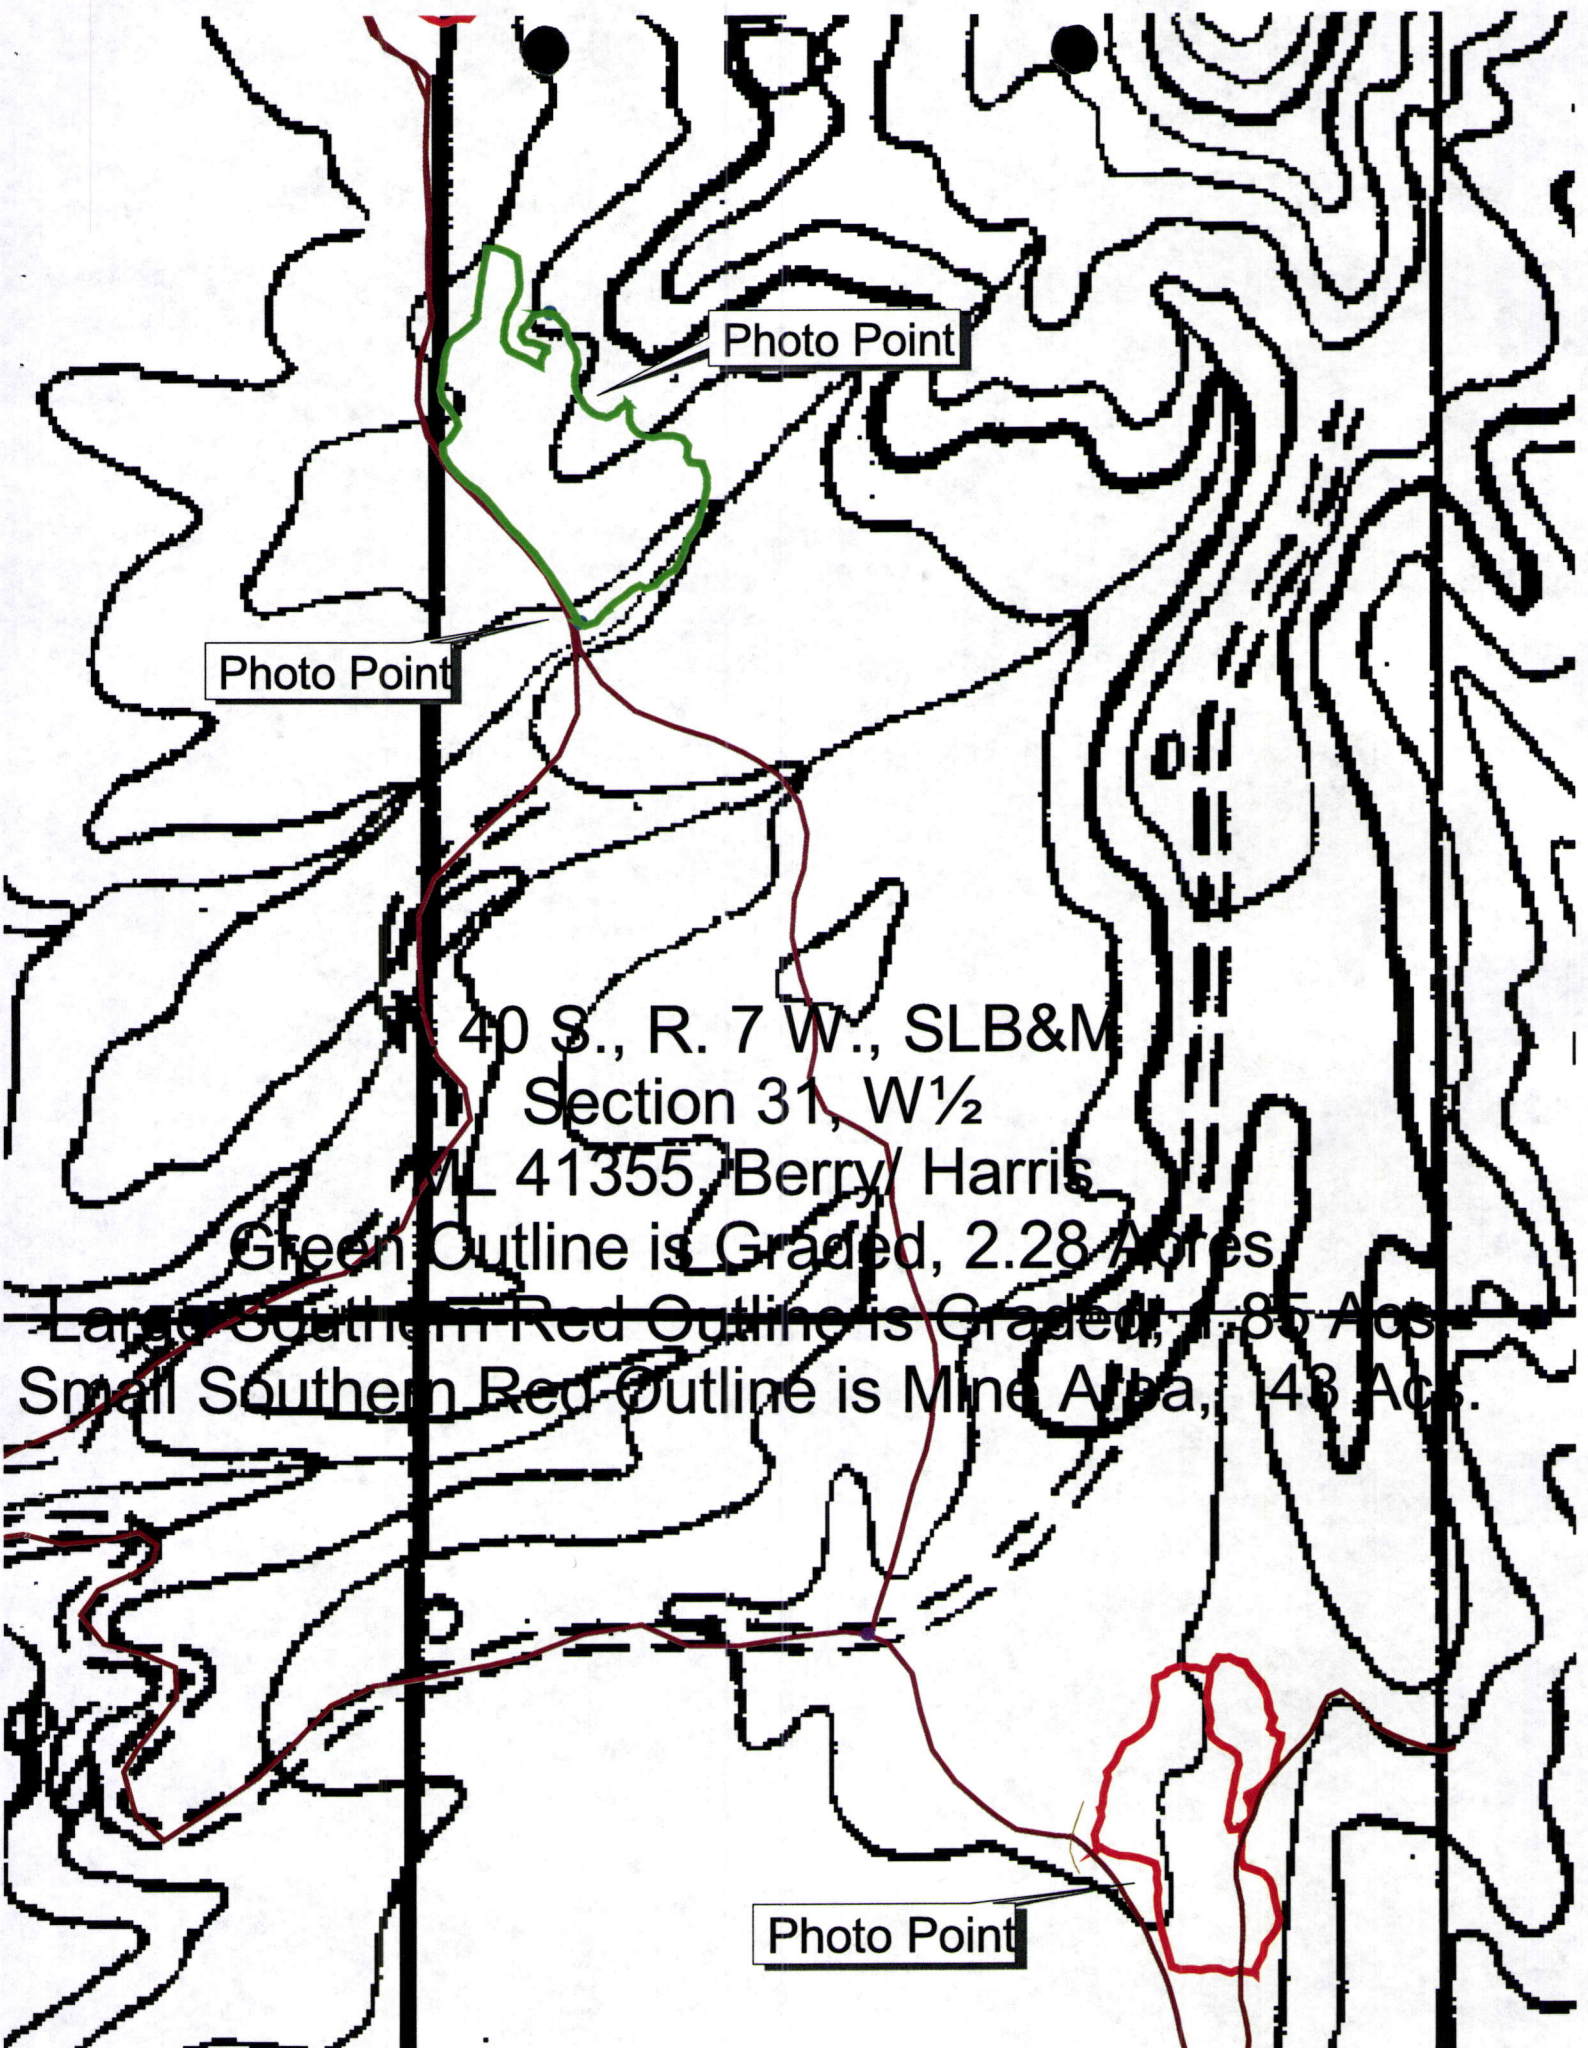
T 40 S., R. 7 W., SLB&M
Section 31, W $\frac{1}{2}$
WL 41355, Berry/ Harris

Green Outline is Graded, 2.28 Acres

Large Southern Red Outline is Graded, 1.85 Acs

Small Southern Red Outline is Mine Area, 143 Acs.

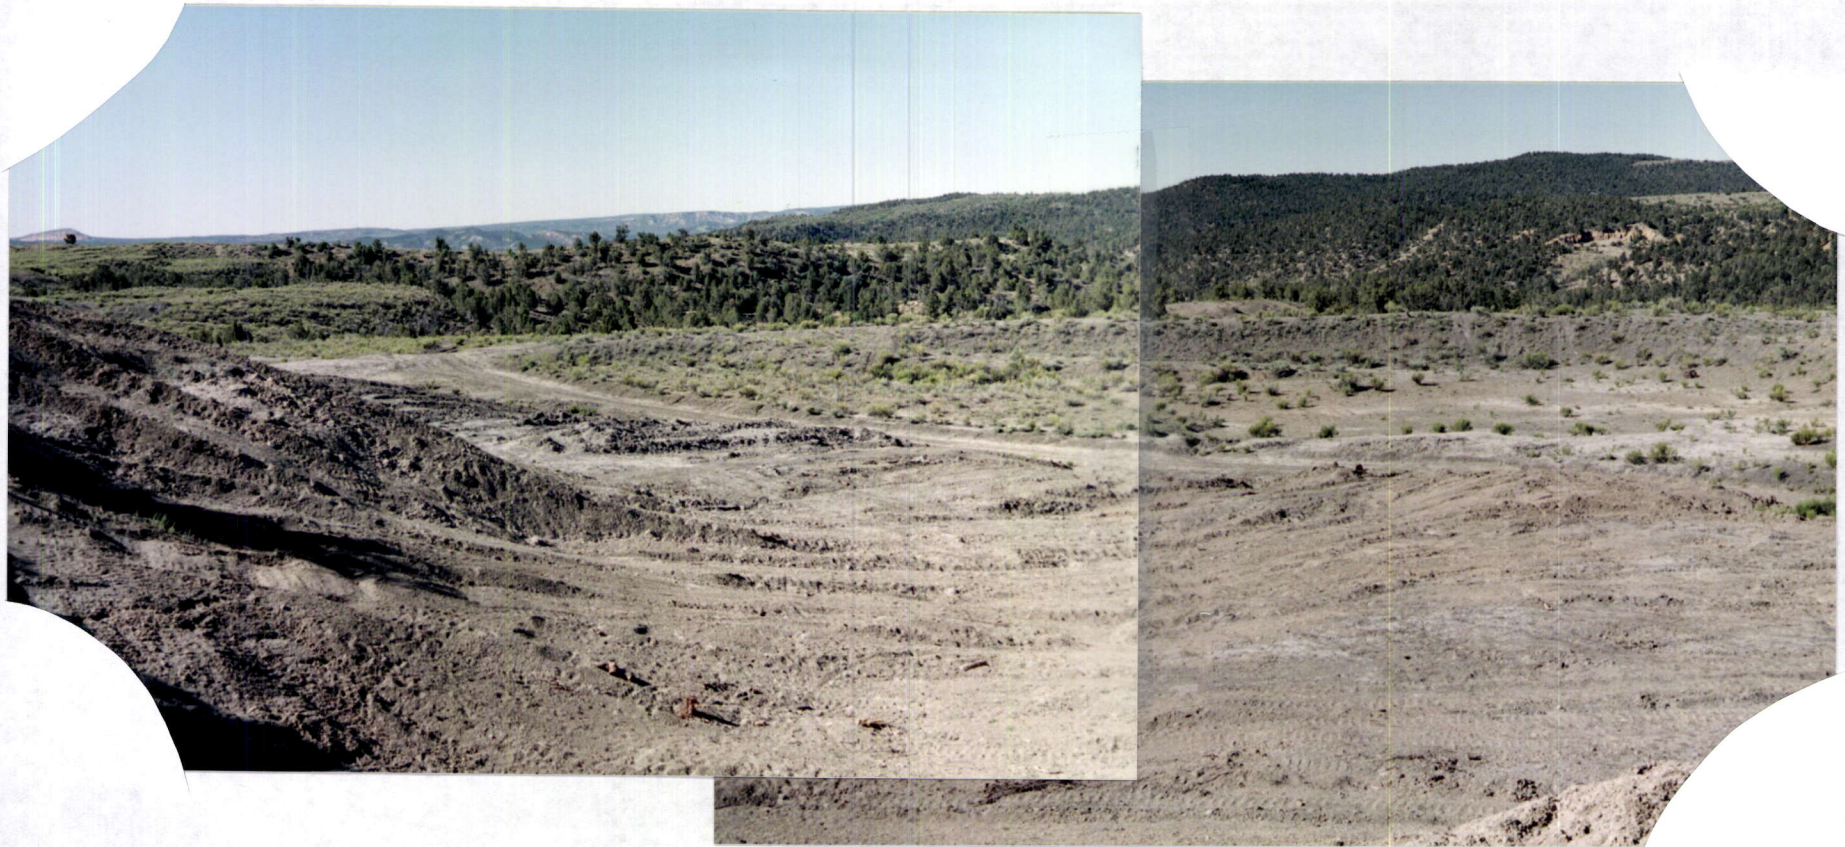
Photograph 13, Looking southwest from the northern most photo point onto the northern graded area as shown on the GPS map for ML 41355.

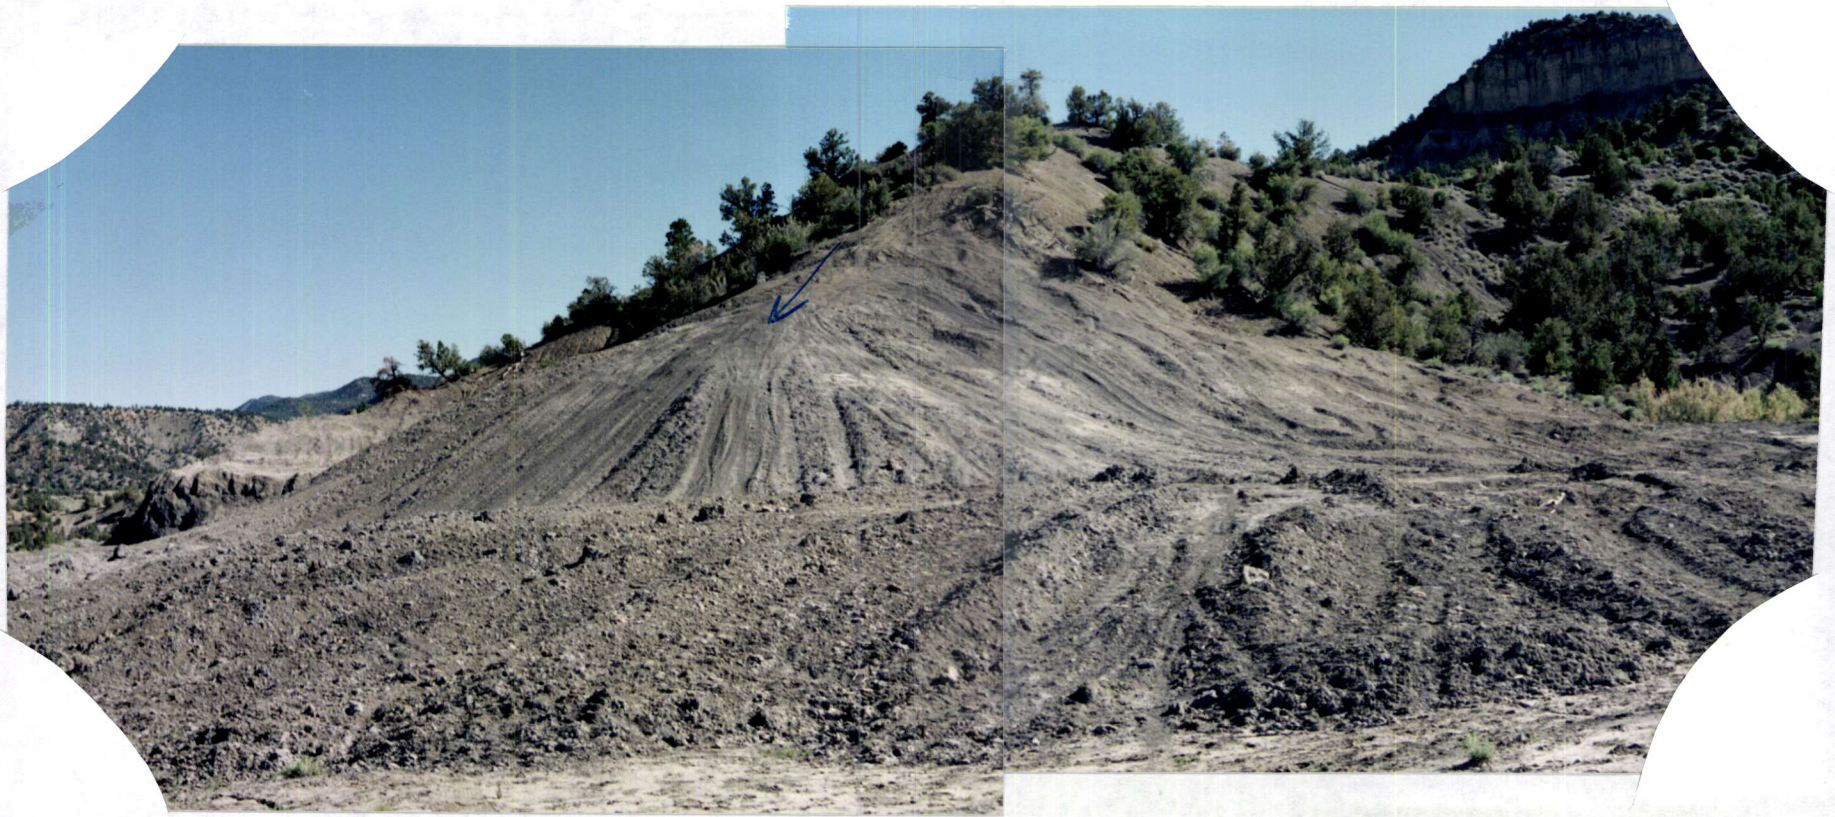
Photograph 14, Looking northeast from the photo point on the southern end of the northern graded area as shown on the GPS map for ML 41355. The arrow indicated the location from where photograph was taken.
